Manhole Inspection Summary

Manhole # S27I__030MH

Location Address: **914 HOLLINS ST**

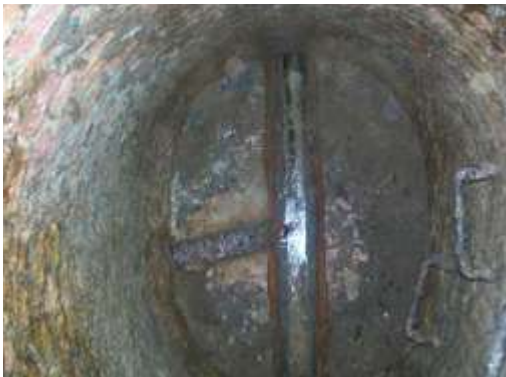
Defect 2

Condition: ☐ Sound ☐ Cracked ☐ Root Intrusion ☐ Loose Brick ☒ **Deteriorated**

Condition: ☐ Sound ☐ Cracked ☐ Root Intrusion ☐ Deteriorated ☐ Leaks ☒ **Debris**

Steps Count: **5** Missing: **0** ☒ **Corroded**

Surcharge ☒ **Evidence Of Surcharge** Depth: **3** (ft.) ☐ Active Surcharge Present

bench debris; corroded steps; surcharge evidence; corbel infiltration; deteriorating corbel and barrel

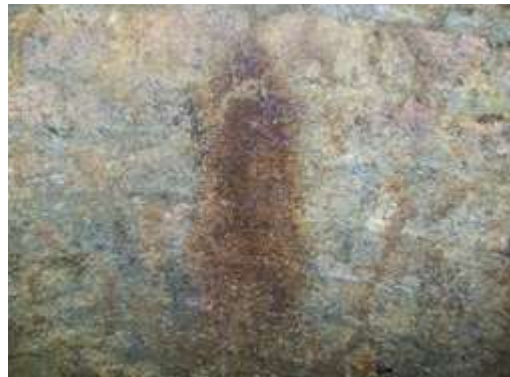
Defect 1

Condition: ☐ Sound ☐ Cracked ☐ Root Intrusion ☐ Loose Brick ☒ **Deteriorated**

Infiltration: ☐ None ☐ Joint ☐ Cracks ☐ Mortar ☐ Roots ☒ **Wall**

INFILTRATION @ BARREL WALL

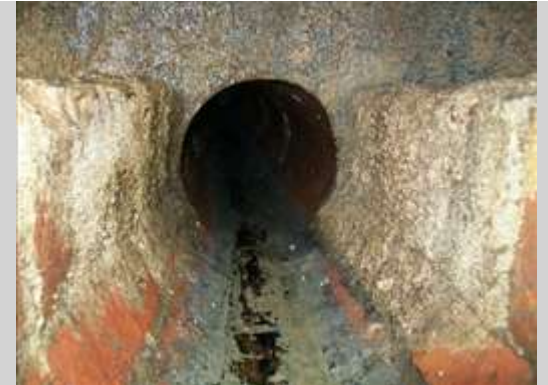
12 O'Clock Outflow

Pipe Height: **8.4** (in.) Rod and Bar (Angled)
Pipe Material: **Clay** ☐ Pipe Lined
Invert Depth: **9.25** (ft.) Flow Characteristics: **Slow**
Deposits: ☒ None ☐ Mud ☐ Sludge ☐ Debris ☐ Grease
Silt Depth: **0** (in.) Deposits Extent:
Infiltration: **None** Pipe Seal Cond: **Sound**

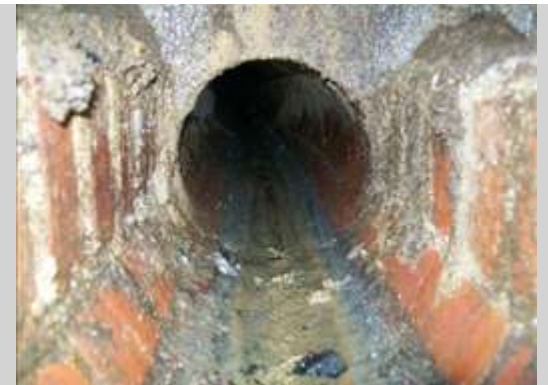
6 O'Clock Inflow

Pipe Height: **8.4** (in.) Rod and Bar (Angled)
Pipe Material: **Clay** ☐ Pipe Lined
Invert Depth: **9.10** (ft.) Flow Characteristics: **Slow**
Deposits: ☒ None ☐ Mud ☐ Sludge ☐ Debris ☐ Grease
Silt Depth: **0** (in.) Deposits Extent:
Infiltration: **None** Pipe Seal Cond: **Sound**

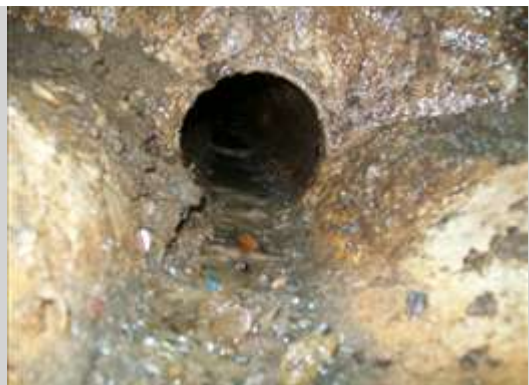
9 O'Clock Inflow

Pipe Height: **6** (in.) Rod and Bar (Angled)

Infiltration: **None**

Pipe Seal Cond: **Sound**
